# **EPIC operations Status 2014**

Pedro Calderón Riaño MPE, Garching 25/03/2014

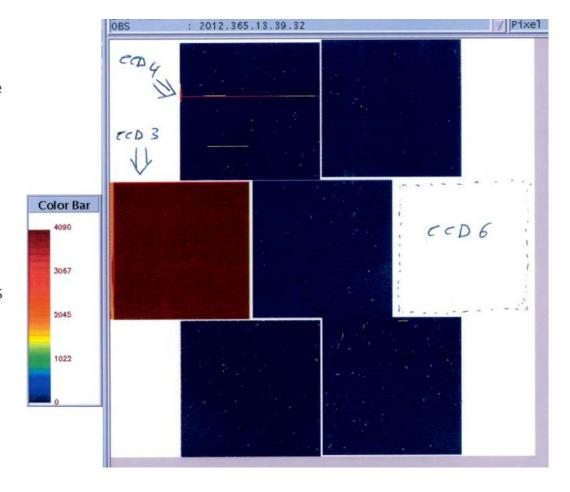
On 11<sup>th</sup> December 2012 a micrometeorite cause a big damage on CCD 3 and a little one on CCD4.

CCD 3 is declared dead, as was CCD 6 on it times.

Since revolution 2516 MOS1 is operated without use CCDs 3, 6, and the related electronics. So now MOS1 is a bit quicker than MOS2 starting observations.

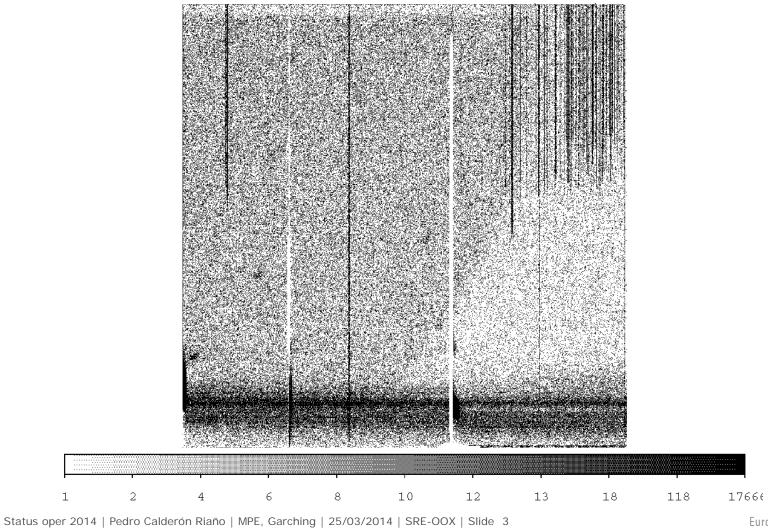
## MOS1 CCD4 damage

- A lot of noise is being generated into CCD4 since micrometeorite impact.
- So much noise as for require the increase to 2.7 seconds of the integration time for allow the EMCR to process it. (Since rev 2412)
- Also the Offset Table version 18 is being used since rev 2553 for delete on-board part of the noisy rows from the border of the CCD, mostly out of the field of view of the telescope.
- A further layer of cleaning is performed on ground within the CCF files for SAS processing.

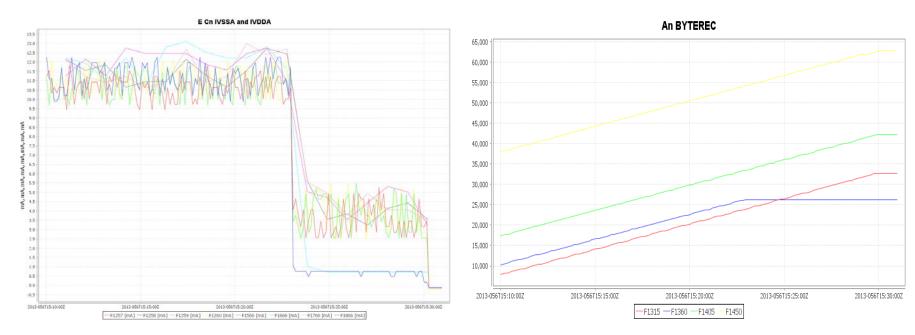
- The PN events happened on 25<sup>th</sup> February and 11<sup>th</sup> April 2013.
  - a. Alarm on CCD currents too low, but not 0.
  - b. Instrument set on Safe Standby, them recover, OK.

- The PN events did not repeated later.
- The tests performed show no failure. All the EPEA and EPCE memories are OK.
- As no new data is available, the provisional conclusion of software glitch on EPCE to EPEA communications, leading to stopped CCD reading that cause the low currents, is still the main suspected cause of the events.
- An OCR is ready to be send in case of a repetition of this event. It
  instruct how further investigate the memories CRCs and a softer EPEA
  reboot as a way to find new clues of the nature of the problem.
