# **EPIC operations Status 2014**

Pedro Calderón Riaño MPE, Garching 25/03/2014

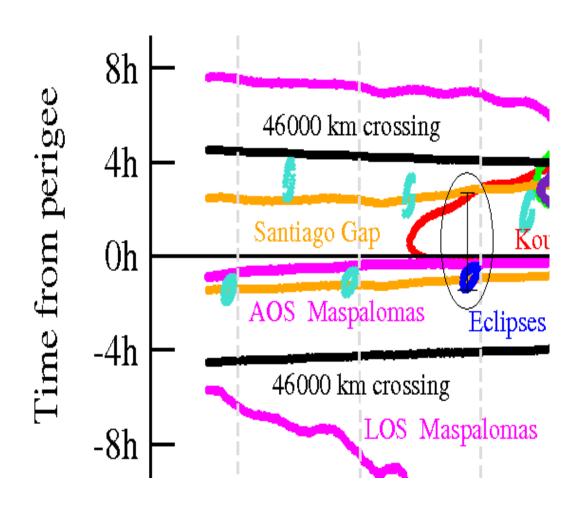
The instruments may be idle up to 4 hours per revolution. No major impact as on perigee the instruments are already idle.

But on eclipse seasons the instruments may be OFF up to 3 hours
